SERVICE BULLETIN

Classification: AT10-004a	Reference: NTB10-121a	Date: June 28, 2011
------------------------------	--------------------------	------------------------

2007 – 2011 ALTIMA SLIGHT VEHICLE HESITATION OR SURGE TYPE FEEL AT LOW SPEEDS

- APPLIED VEHICLE:** 2007 – 2011 Altima (L32 and CL32) Sedan and Coupe
APPLIED TRANS: CVT only
APPLIED ENGINE: QR25 only

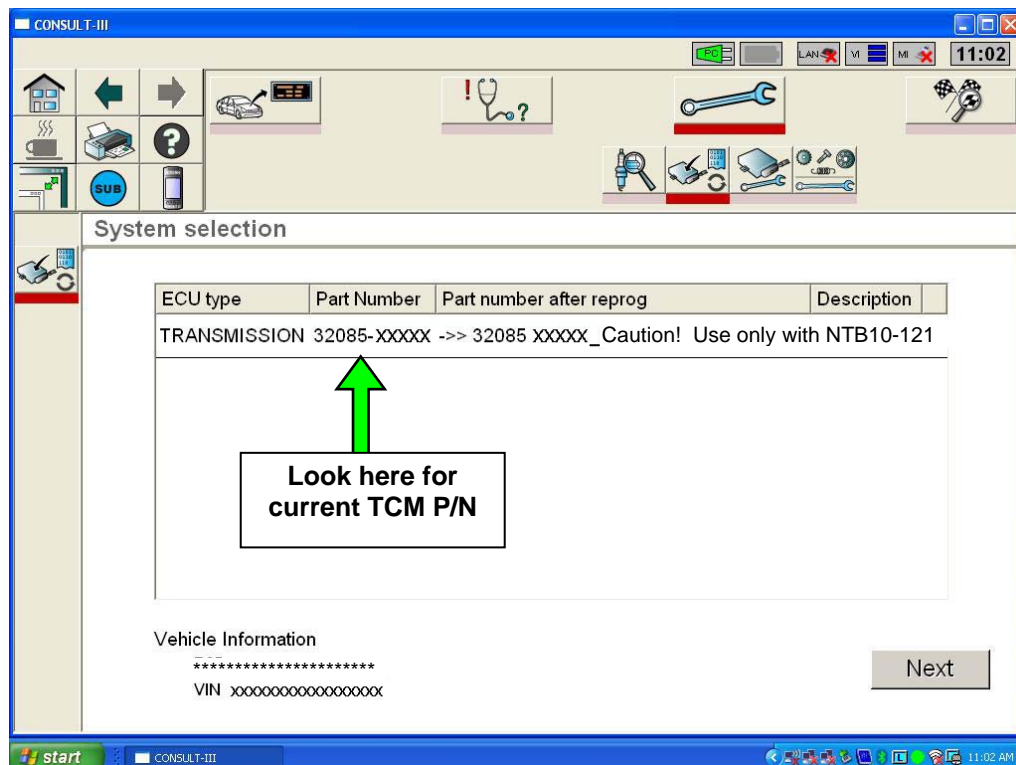
Figure 1

2. When you get to the TCM Reprogramming screen shown in Figure 1, confirm TCM reprogramming applies as follows.
 - A. On your C-III screen, look at the **Part Number** (P/N) column (see Figure 1).
 - Write down the P/N on the Repair Order.

B. Compare the P/N you wrote down to the numbers in the **Current TCM P/N** column in **Table A** below.

- If there is a match this bulletin applies. Continue with the reprogramming procedure.

- If there is not a match, this bulletin does not apply. Refer to ASIST for further diagnostic information.

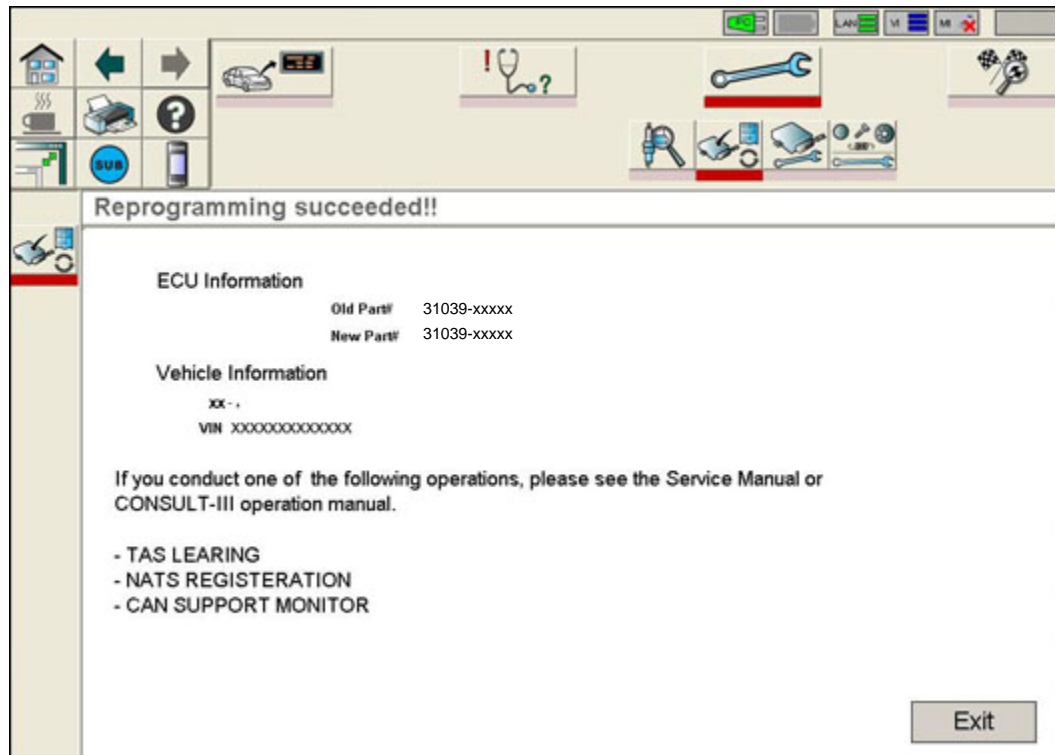
3. If this bulletin applies and you have performed TCM reprogramming, the screen in Figure 2 displays when reprogramming is complete.

Print this screen and attach it to the Repair Order for Warranty documentation.
